YELLOW CREEK STATE PARK DAM
NDI I.D. NO: 282

PHASE I INSPECTION REPORT
NATIONAL DAM INSPECTION PROGRAM

D'APPOLONIA CONSULTING ENGINEERS
10 DUFF ROAD
PITTSBURGH, PA. 15235
SEPTEMBER 1978

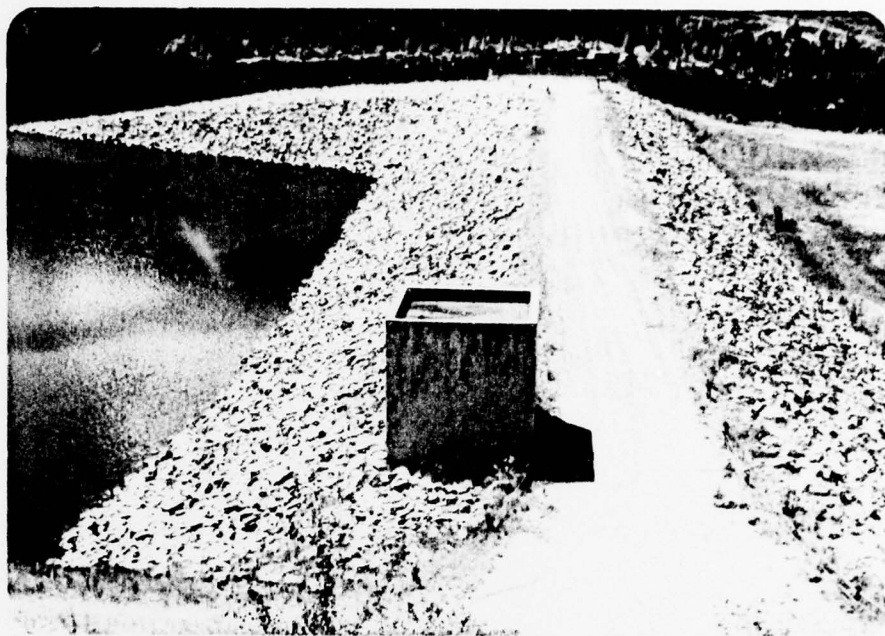
Photograph No. 1
Crest (looking south).

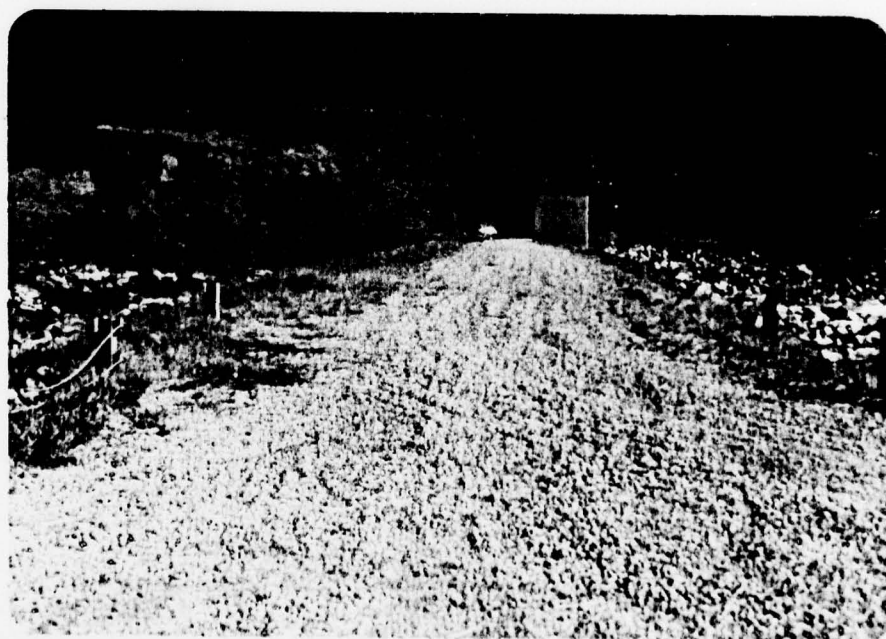
Photograph No. 2
Crest (looking north).

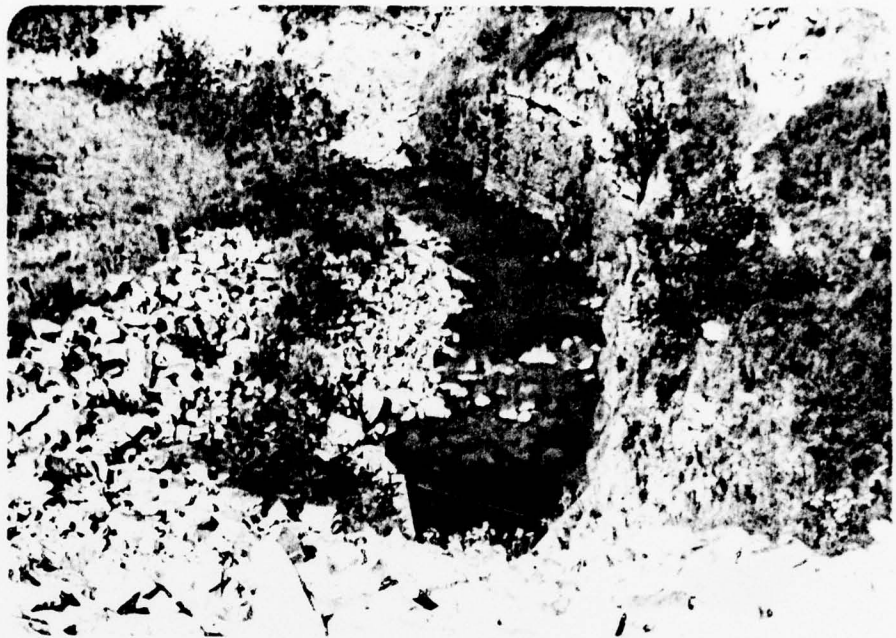
Photograph No. 5

c. Appurtenant Structures. The appurtenant structures were examined for deterioration or other signs of distress and obstructions that would limit flow. In general, the structures were found to be in good condition. Severe erosion of rock was observed along the concrete walls on the right side of the spillway discharge channel. Some sections of the wall foundations were exposed by three to four feet. This erosion reportedly occurred in July 1977. Minor rock slides were observed in the outlet works discharge channel. The appearance of the cut along the right side of the outlet works discharge channel suggested the potential for rock slides that could result in the blockage of the outlet works discharge channel.

Outlet pipe discharge channel (note
rock slide into channel).

3. The rock cut along the right side of the outlet works discharge channel should be periodically observed and necessary maintenance performed to avoid rock slides into the channel that may block the flow.
4. It is recommended that the outlet conduit sluice gate be repaired to permit adequate seating of the gate.
5. It is recommended that the owner develop a formal warning system to alert the downstream residents in the event of an emergency.
6. The owner should be advised that the dam and appurtenant structures should be inspected regularly and necessary maintenance should be performed.
